OUT-OF-PLANE PERFORMANCE OF FULL-SIZE UN-REINFORCED BRICK WALLS RETROFITTED WITH EXPANSIVE EPOXY

By A. Zeiny¹ and J. Larralde²

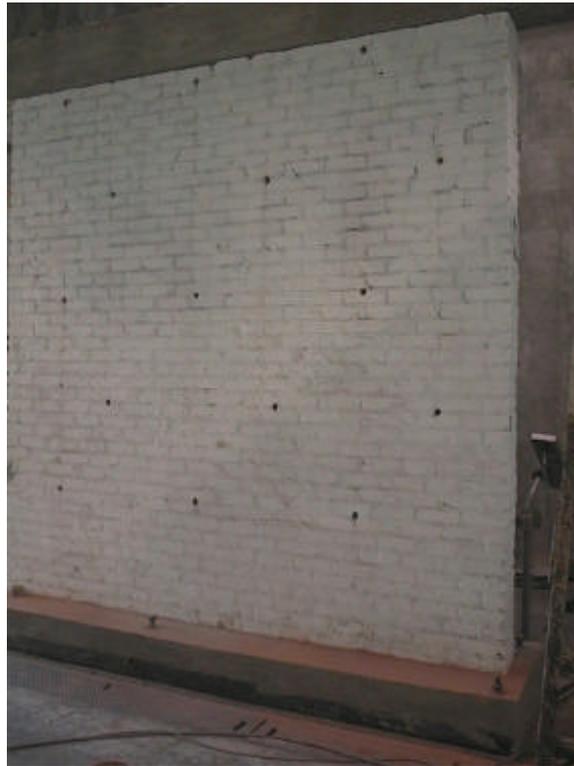
Figure 1: Distribution of Holes on the Wall

construction, holes are drilled in the outside bricklayer to reach to the 2-inch gap to pump the expansive epoxy in a liquid form. The holes are drilled in a diamond shape distribution as shown in Fig. 1 with 2 feet spacing on center. Expansive epoxy is pumped at about 70°F temperature in the lowest row of holes till it leaks out from neighbor holes showing that this particular section of the wall is full of epoxy as shown in Fig. 2. Then after few minutes, the foam starts to expand and hardens. The expansion ratio varies depending on thermal characteristics and confinement of the surrounding. In this test, the expansion ratio for all walls is estimated to be 1:3.8. The necessary time for the foam to cure is seven days. The method can also be implemented for brick walls with single layer of brick. The approximately 2 inch of void area can be created by the use of common plywood and drywall.

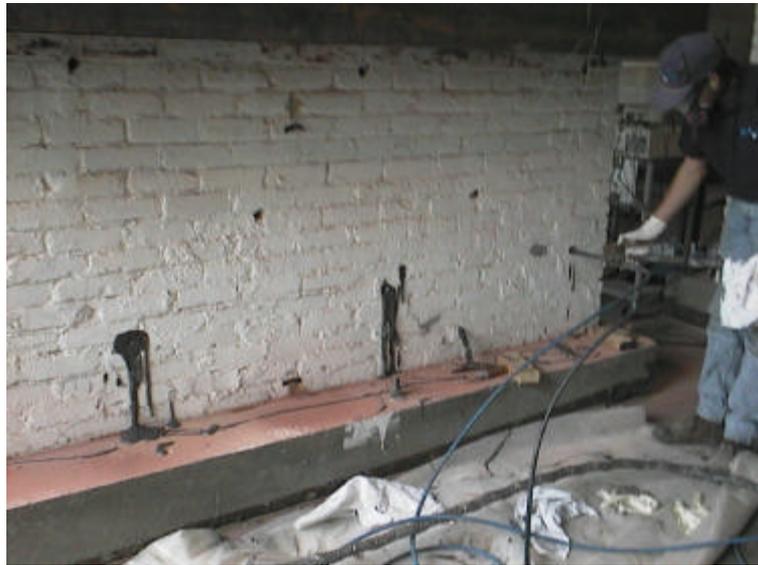
Figure 2: Pumping of Expansive Epoxy in the Wall
