HORIZONTAL SHEAR PERFORMANCE OF FULL-SIZE UN-REINFORCED BRICK WALLS RETROFITTED WITH EXPANSIVE EPOXY

By J. Larralde¹ and A. Zeiny²

This paper presents the results of tests of un-reinforced brick walls retrofitted and repaired with expansive epoxy. The walls were subjected to horizontal, in-plane shear force and their response was monitored under a wide range of cyclic loading. A new type of epoxy formulation was tested to determine its potential for structural retrofitting and strengthening of existing brick masonry buildings. Full-size, un-reinforced brick walls of 10 ft by 10 ft were fabricated using aged brick and masonry mortar to simulate the conditions existing in old brick buildings. One wall was loaded directly as plain, un-reinforced brick wall and was used as control. Another wall, identical to the first one was first injected with the expansive epoxy, allowed to cure for seven days and then tested under identical support and loading conditions. After the first (plain) wall was loaded beyond its full cracked state, it was then repaired with the expansive epoxy and re-tested. The results of the tests demonstrate the strengthening and repairing effects of the expansive ep

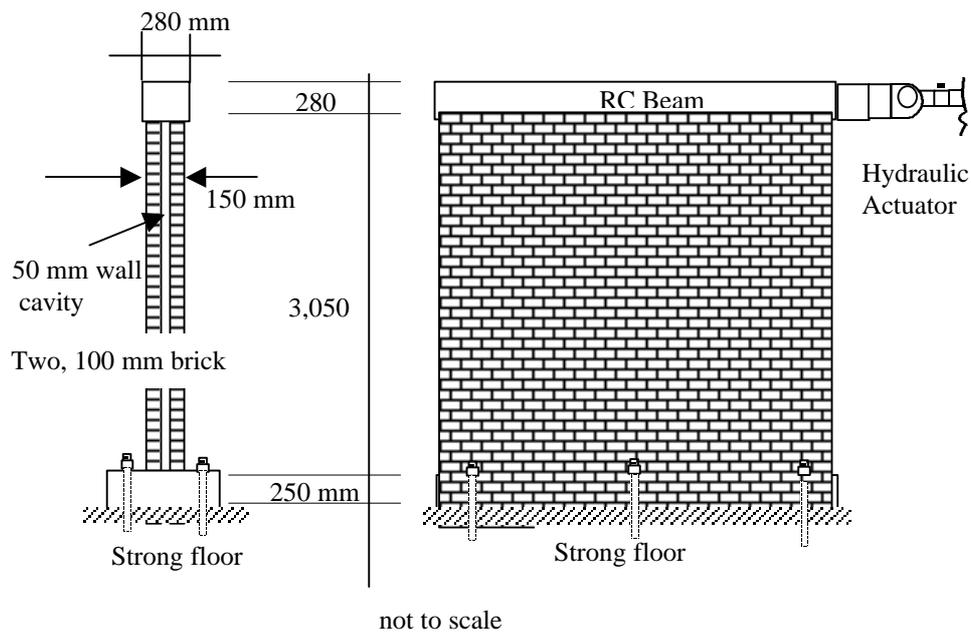
Figure. 1 Schematic of test set up and dimensions of wall

Two, un-reinforced brick walls of 3.0 m (10 ft) by 3.0 m (10 ft) were built in the testing bay of the structures laboratory at California State University, Fresno. The walls were tested under horizontal, in-plane shear force applied at the top of the walls. The following tests were conducted: as built (control), as built and retrofitting, and after being cracked and then repaired.

The walls consisted of two wythes each approximately 100 mm (4 in.) thick, with a 50 mm (2 in.) empty cavity in between. The walls were built on top of a reinforced concrete beam of approximately 780 mm (31 in.) wide, 250 mm (10 in.) tall, and 3.10 m (10-1/3 ft) long which was firmly anchored with six 30 mm (1-1/4 in.) threaded rods to the strong floor of the test bay. The walls were fixed at the base and free to move in all directions at the top so they were tested as cantilever shear walls. The force was applied at one end of the cap beam with a computer controlled hydraulic actuator which was attached to the reaction wall through a hinge mechanism. The force, thus, was applied horizontally and parallel to the wall.

The various wall configurations were tested applying cyclic load under controlled displacement conditions and with gradually increasing amplitude. The hydraulic actuator was attached through a hinge to the reaction wall at one end, and attached to the a cap, reinforced concrete beam at the other end. Thus the actuator was in part supported by the tested wall. The list of the test conducted with in-plane shear force is shown in Table 1.

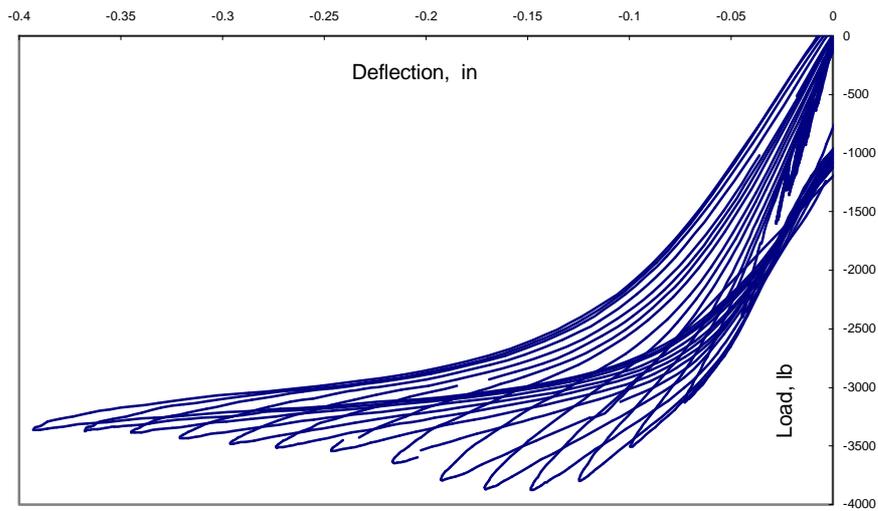
Figure 2. Load-deflection diagram of test No. 1 (control)

The test results in terms of maximum load for each wall and test condition are summarized in Table 2. In test 1 the intend was to just crack the wall to then repair it and test it again to simulate the conditions of a repaired wall that has already cracked. In this test, the plain wall failed in tension at the horizontal mortar joints near the base.

After the cracks formed the portion of the wall above the cracks started to uplift and rock in a rigid body motion. The ultimate load was 17,200 N (3860 lb) and there was no indication of diagonal shear failure.

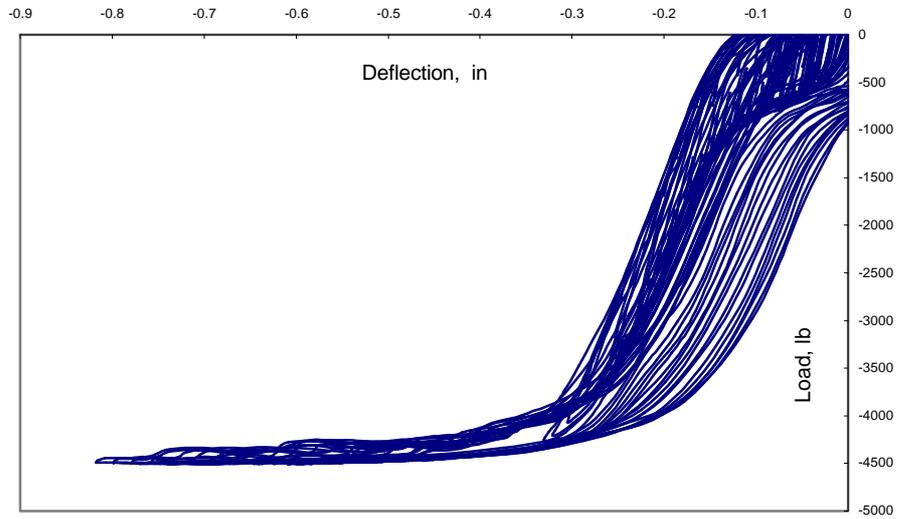
Figure 3. Load-deflection diagram of test No. 2

In test No 2 , the wall tested previously as described above was then repaired by injecting the expansive epoxy. After the epoxy set, the wall was tested under monotonic increasing load and then under cyclic loading.

In the first part, under the monotonic load, the wall was pulled to a horizontal displacement at the top of 6.4 mm (0.25 in.) developing a load capacity of 25,600 N (5750 lb). Under the cyclic loading and after having been already loaded to 25,600 N, the wall exhibited a capacity of 20,000 N (4500 lb) at an asymptotic displacement from 10 mm (0.4 in.) to 20 mm (0.8 in.). It was observed that the cracks that formed during the first test remained together as a result of the epoxy. In addition the epoxy maintained the integrity of the wall proving load transfer across the cracked mortar material. The epoxy is ductile and allows large deformation before it fails. This allows more energy absorption and dissipation in seismic events. After the wall finally failed in tension by cracking at the horizontal mortar joints near the base, the wall above the cracked sections started to rock in a rigid body motion and there were no signs of diagonal shear failure.

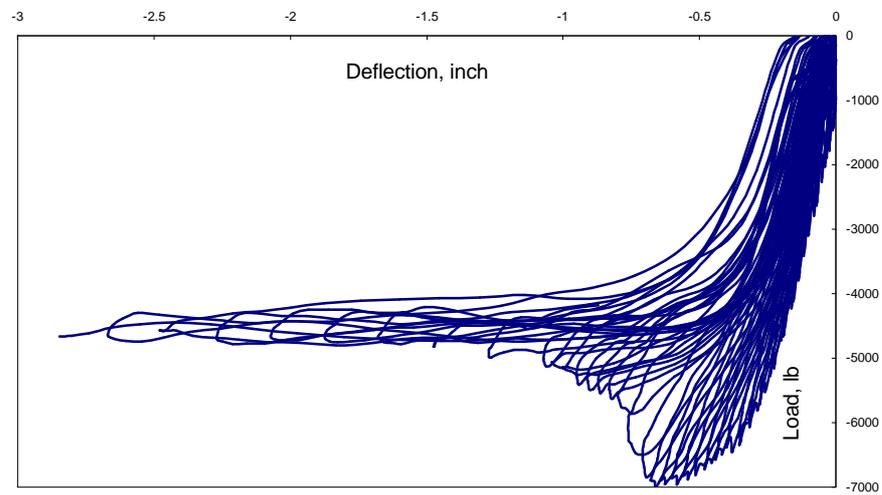
Figure 4. Load-deflection diagram of test No. 3

In test No 3, the wall tested as indicated before was then repaired by applying a fiberglass/epoxy mat at the base of the wall and firmly attached to the floor. The cracks

formed in the previous test were then sealed with the fiberglass and epoxy. The wall tested under cyclic loading developed new horizontal cracks just above the limit of the fiberglass mat and was able to carry a maximum load of 31,100 N (7000 lb). This considerable increase in load capacity is attributed to the fact that the fiberglass reinforced the base of the wall where the epoxy injection may not have filled the spaces properly, forcing new cracks to occur above the level of the limit of the fiberglass where the epoxy filled the spaces better.

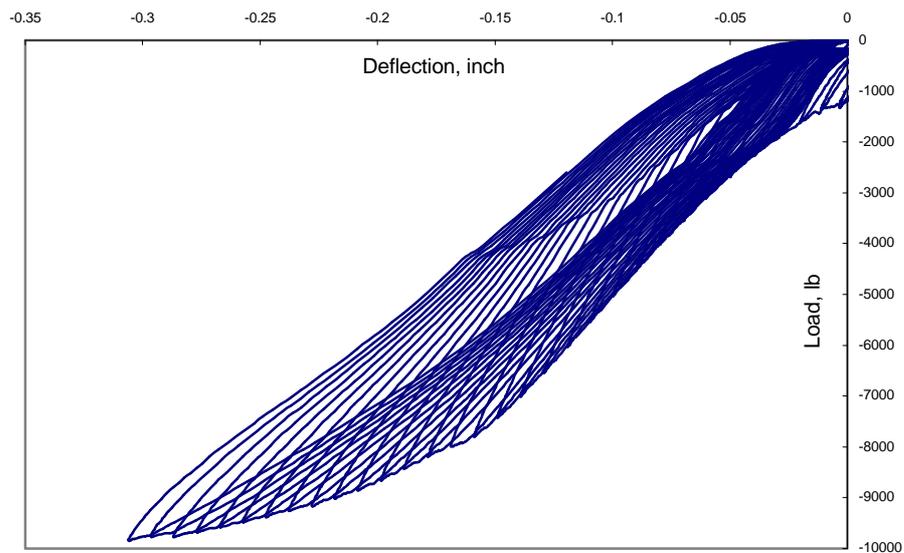
Figure 5. Load-deflection diagram of test No. 4

In test No 4, a new plain wall was retrofitted with the expansive epoxy and also was subjected to a heavier axial load. Two concrete blocks with a total weight of 48,900 N (11000 lb) added an extra vertical axial stress of 79 kPa (11.5 psi). The wall was then tested under cyclic loading and developed a maximum capacity of 44,500 N (10000 lb) at a horizontal displacement of 7 mm (0.31) when horizontal cracks developed. To continue the test, the wall was then reinforced with vertical external reinforcement by attaching two steel chains at both ends of the wall.

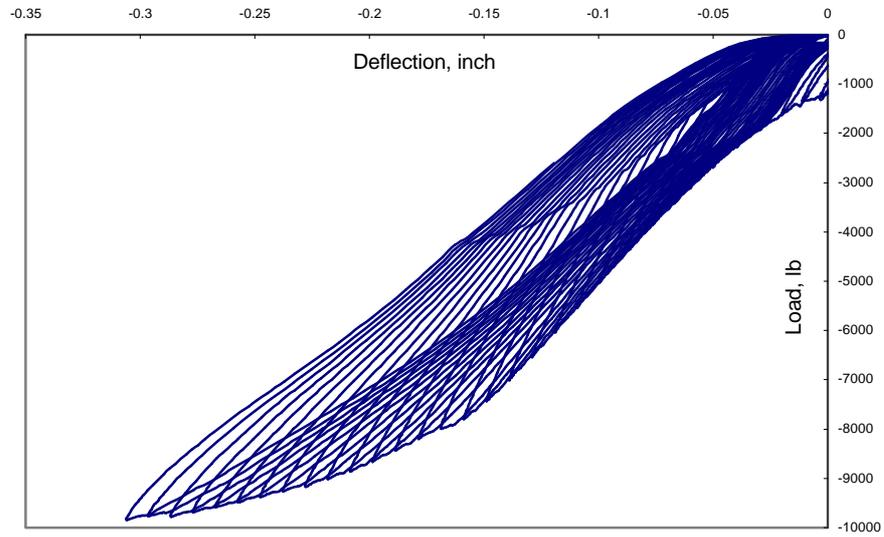
Figure 6. Load-deflection diagram of test No. 5

The wall was then tested (Test No 5) under cyclic loading again. The extra reinforcement would simulate the effect of heavy axial loading resulting from dead load of supported floors. The chains did not prevent the formation of the horizontal cracks since they were not prestressed and they deformed appreciably before applying the axial load. As the magnitude of the cyclic load increased the wall uplifted at the cracked sections until the restraint of the chains against uplift was such that the wall slipped approximately 50 mm (2 in.) from the foundation beam. The wall showed no signs of diagonal shear although the maximum load increased considerably.

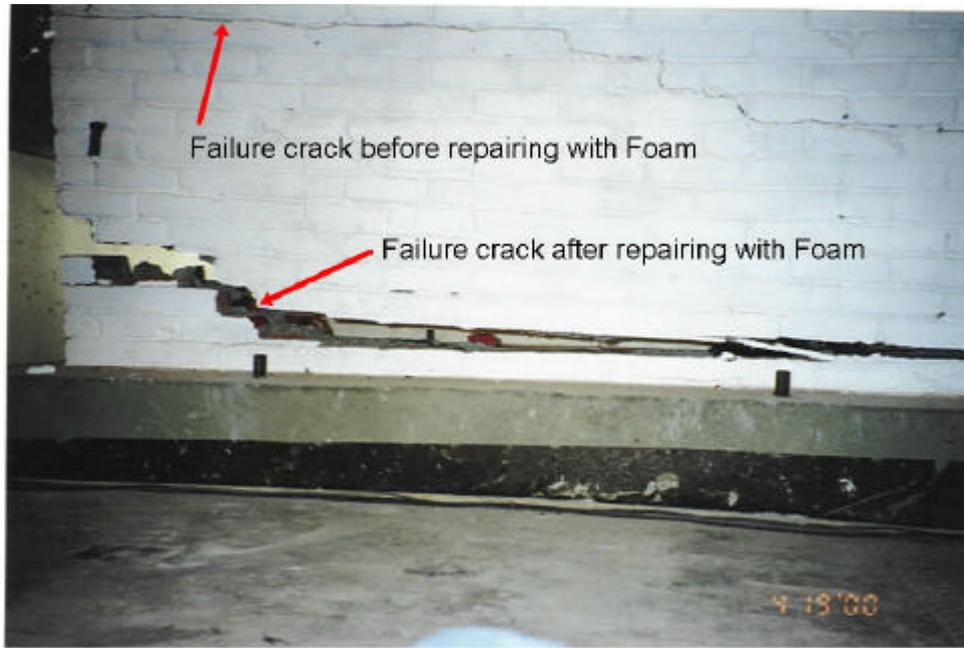
Figure 7. Failure Cracks of the In-Plane Wall Before and After Repairing with Foam
