Evaluation of the Seismic Performance of Brick Walls Retrofitted and Repaired by Expansive Epoxy Injection

Al Zeiny, Ph.D, P.E.¹

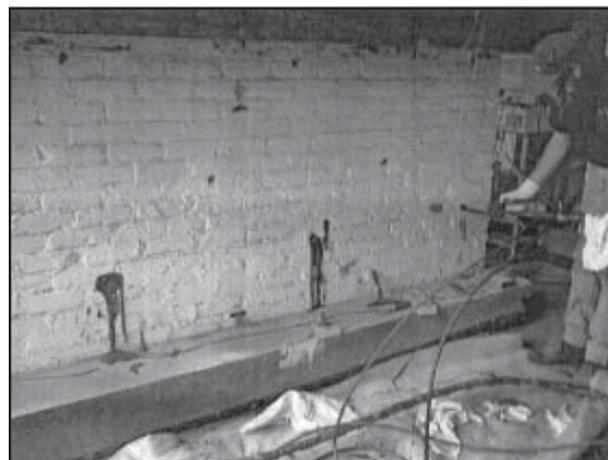
Figure 1—Pumping of Expansive Epoxy in the Wall

The expansive epoxy is a monolithic complex composite. This composite material, when injected into a void area within the walls of buildings, as shown in Figure 1, has the potential to increase the ductility, damping and strength of these walls.

One type of construction of brick walls of historical buildings consists of two layers of brick with 2-inch gap in between to provide insulation. To retrofit this kind of construction, holes are drilled in the outside bricklayer to reach to the 2-inch (50.8 mm) gap to pump the expansive epoxy in a liquid form. The holes are drilled in a diamond shape distribution with 2 feet (610 mm) spacing on center. Expansive epoxy is pumped at about 70°F (21°C) temperature in the lowest row of holes till it leaks out from neighbor holes showing that this particular section of the wall is full of epoxy as shown in Figure 1. Then after a few minutes, the expansive epoxy starts to expand and hardens to fill the two-inch gap in

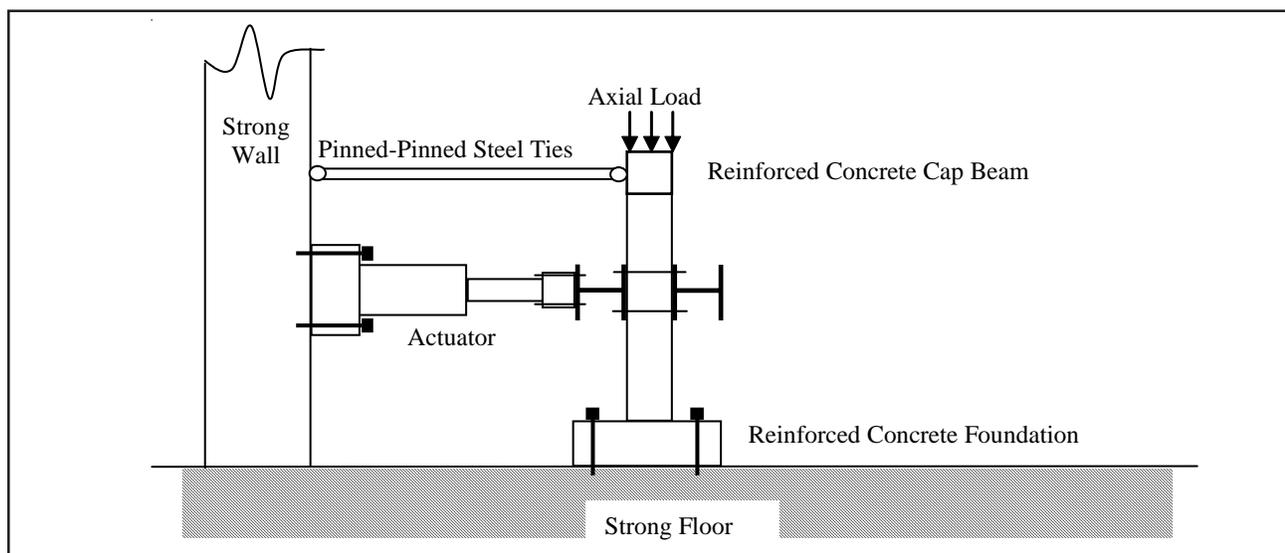
Figure 2—Out-of-Plane Bending Test Set-up

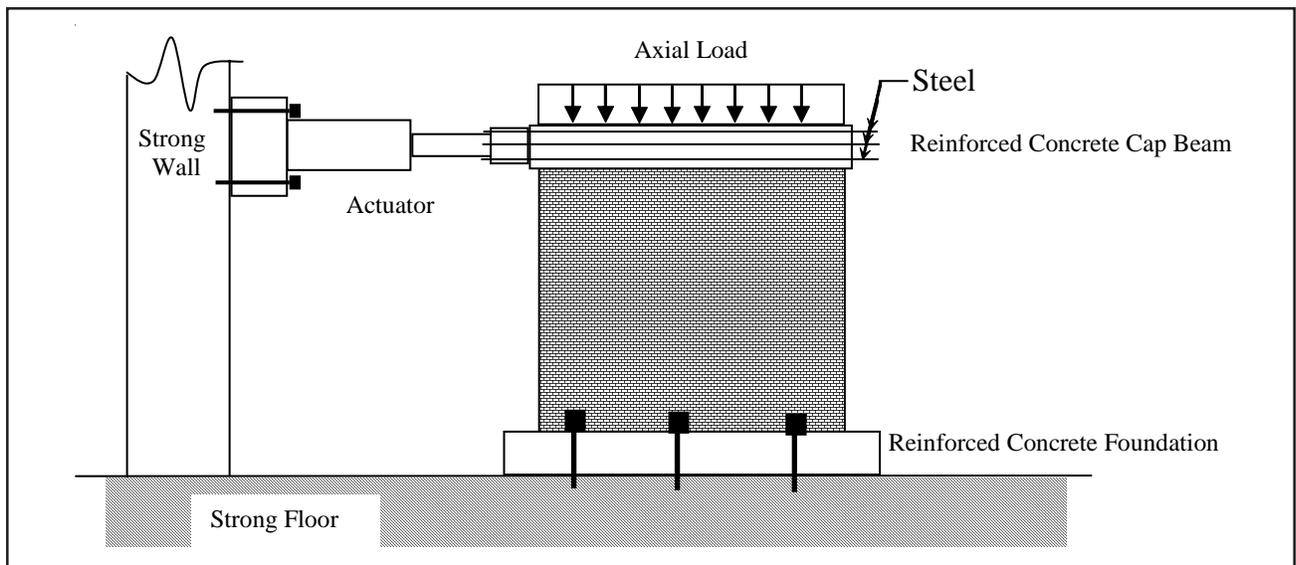
Figure 3—In-Plane Shear Test Set-up

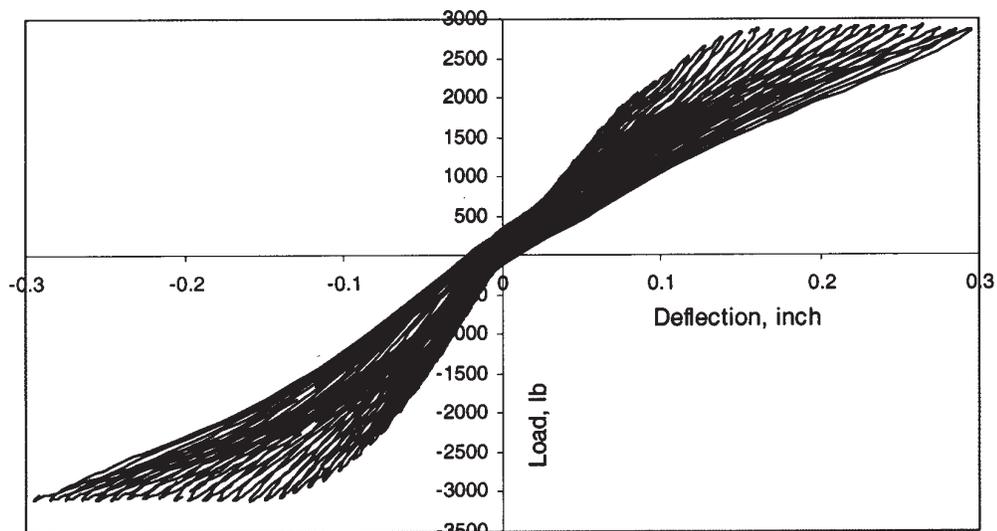
The load deflection curve Figure 4 shows typical hysteresis loops with expected stiffness degradation. The ultimate capacity of the plain brick wall was 3,000 lbs (13.3 kN). The wall started to crack at about 2,000 lbs (8.9 kN)

Figure 4—Load-Deflection Curve for Out-of-Plane Loading of Un-Injected Wall

and 0.1-inch (0.25 mm) deflection. The wall became fully cracked at 0.15 inch (3.81 mm) deflection. Increasing the displacement more than 0.15 (3.81 mm) inch caused the wall to deform in a rocking mode where the cracks will simply open and close without providing any resistance. As the deflection started to approach a value of 0.3 inch (7.62 mm), the wall showed signs of collapsing. The test was then stopped to prevent the wall from going into catastrophic failure where the bottom of the brick wall would slide out of the plane of the wall and the entire wall could then collapse. It was intended from the beginning to just crack the wall, to repair it, and then test it again. Two horizontal cracks were observed: one right above the horizontal steel beam connected to the actuator and the other at the bottom of the wall near the foundation. These two cracks separate the wall into three separate pieces; one below the bottom crack, the second between the bottom and middle cracks and the third above the middle crack. The wall could have slid out of its plane along these two cracks causing a catastrophic brittle failure.

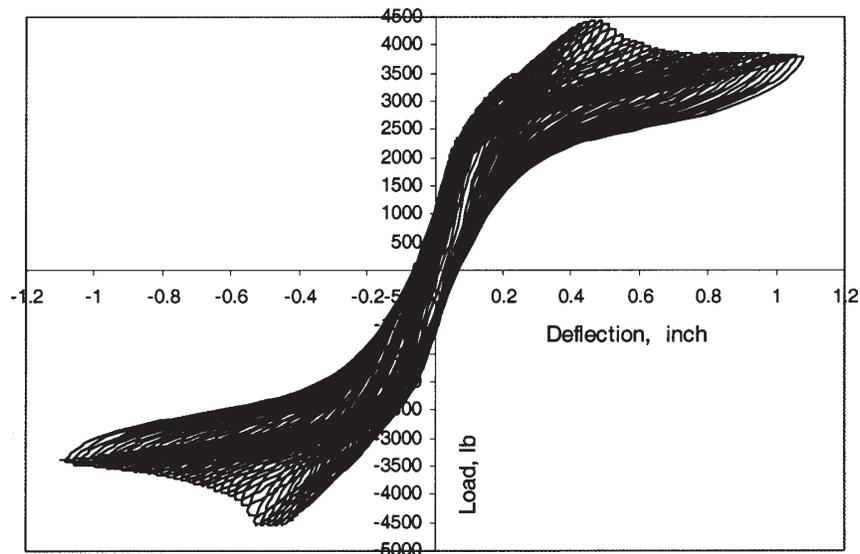
Figure 5—Load-Deflection Curve of the Out-of-Plane Repaired Wall – Phase I: Up to 1 in. (25 mm) Deflection (1 in. = 25.4 mm, 1 lb = 4.448 N)

Figures 5 and 6 show hysteresis loops for both phases. The wall has reached to a deflection of five inches in both directions without catastrophic failure as shown in Figure 7. Two horizontal cracks were observed: one right above the horizontal steel beam connected to the actuator and the other at the bottom of the wall near the foundation. At each horizontal crack, a plastic hinge was formed with a length equal to the length of the wall. Such ductile plastic hinges were not possible to form without the expansive epoxy. In addition, the maximum load observed has increased from 3,000 lb (13.3 kN) in the plain wall to 4,500 lb (17.8 kN) in the expansive epoxy-repaired wall, which is 24% increase. This indicates that the injection of the expansive epoxy not only restored the strength of the cracked wall by sealing all previous cracks, but also increased the strength by 50%.

Figure 5 shows the ultimate strength of the repaired wall at a value of 4,500 lbs (20 kN), which is 1,500 lbs (6.7 kN) more than the plain brick wall. Figure 6 shows that the wall is

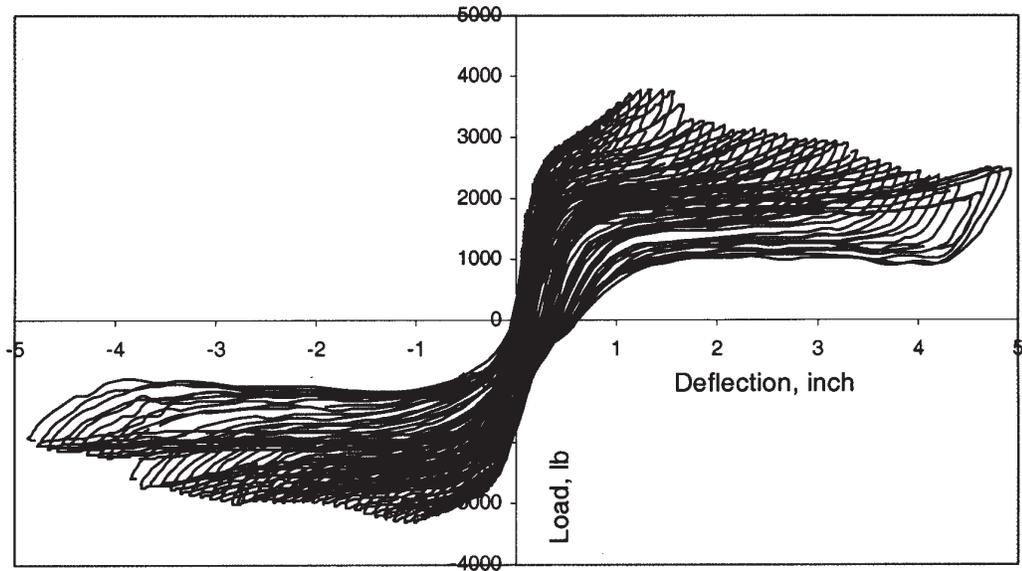
Figure 6—Load-Deflection Curve of the Out-of-Plane Repaired Wall – Phase II: Full Deflection Range (1 in. = 25.4 mm, 1 lb = 4.448 N)

very ductile because it took a deflection up to five inches without collapsing. This ductility is attributed to the formation of the plastic hinges in the middle and at the bottom of the wall. One may argue that the wall was prevented from catastrophic failure because the actuator laterally braced it. Such an argument is not valid because the load did not reverse sign. In other words, if the wall is prevented from collapsing by the actuator, then the force in the actuator will be tension instead of compression in one direction, or compression instead of tension in the other. But the shown load deflection

curve in Figure 6 is showing that up to five inches of deflection, the actuator had to push/pull the wall with a force of 2,100 lbs (9.3 kN) to produce a five inch deflection, i.e. the wall still has a resistance of 2,100 lbs (9.3 kN) at 5 inches (127 mm) of deflection. If the applied actuator force of 2,100 lbs (9.3 kN) is removed, then the wall will return to a position close to the at rest position. This magnitude of deflection is very ample to prove a very ductile behavior of the originally very brittle brick wall keeping in mind that the maximum

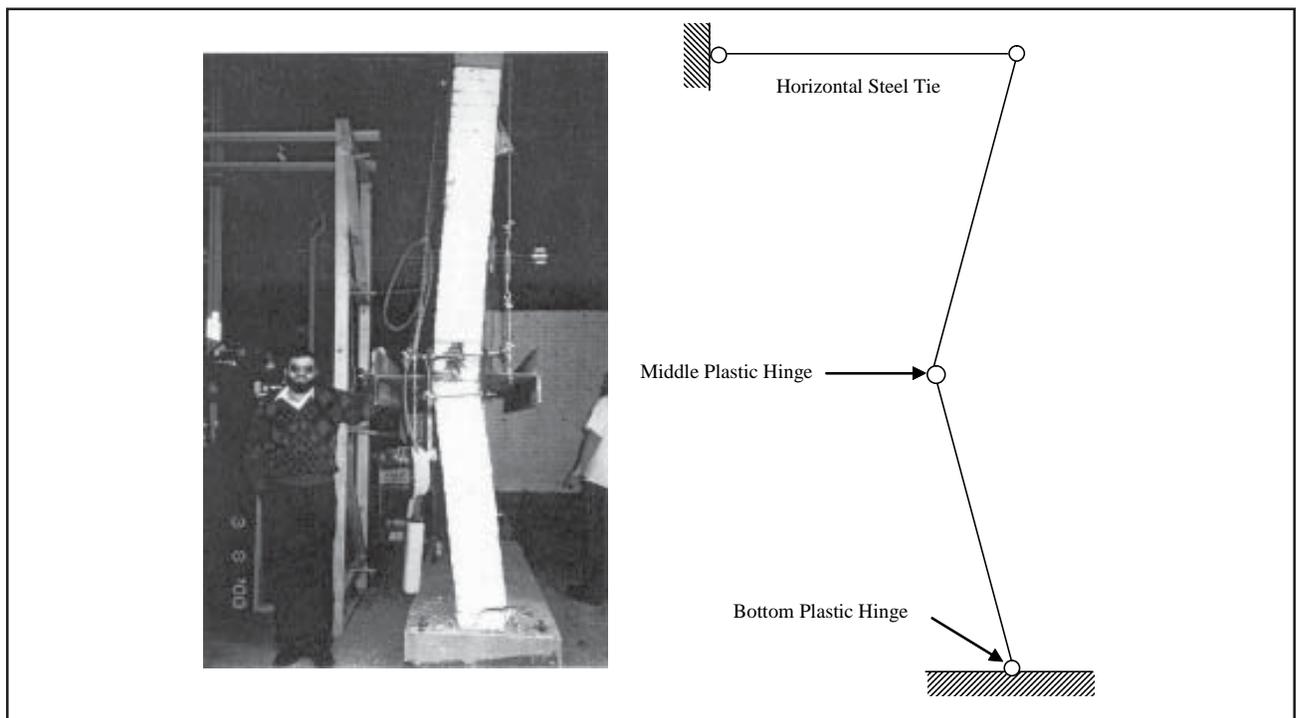
Figure 7—Failure Mechanism of the Out-of-Plane Repaired Wall

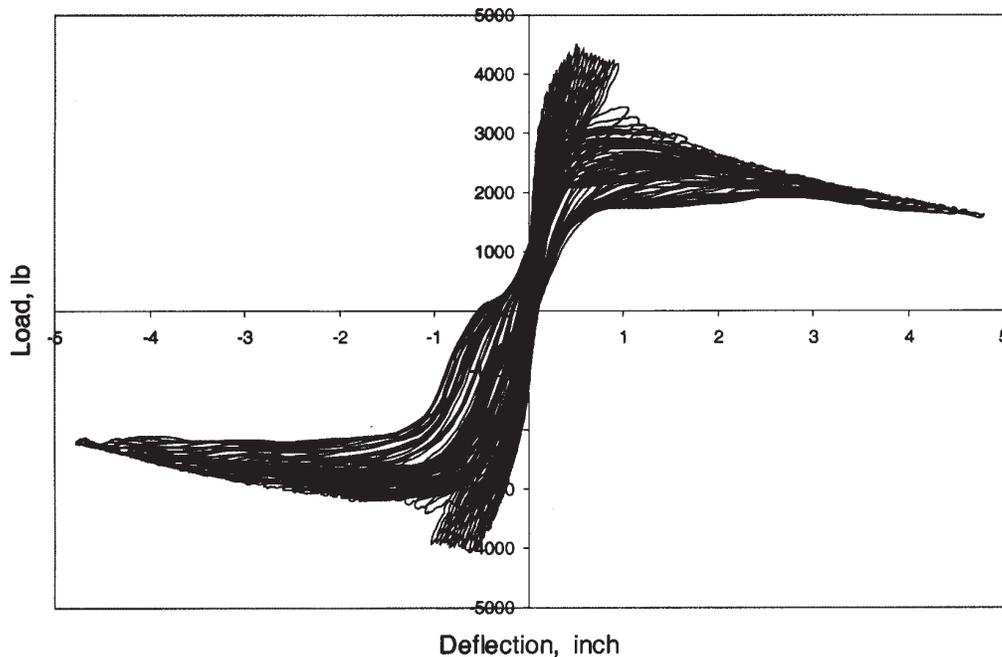
Figure 8—Load-Deflection Curve of the Out-of-Plane Retrofitted Wall (1 in. = 25.4 mm, 1 lb = 4.448 N)

Comparing the load-deflection curve of the retrofitted wall to the repaired wall shows that the load required to form the plastic hinge increases by 20%. Another observation in the retrofitted wall is the sudden drop of load after the formation of the plastic hinge. This sudden drop of load is attributed to the cracking of the brick mortar in brittle mode. In the repaired wall, this crack has already taken place when the wall was initially cracked before the injection of the expansive epoxy. This explains why we see gradual drop of load with the increase of deflection beyond the formation of the plastic hinges in the repaired wall, while a sudden drop of load is observed in the retrofitted wall that has not been cracked prior to be tested.

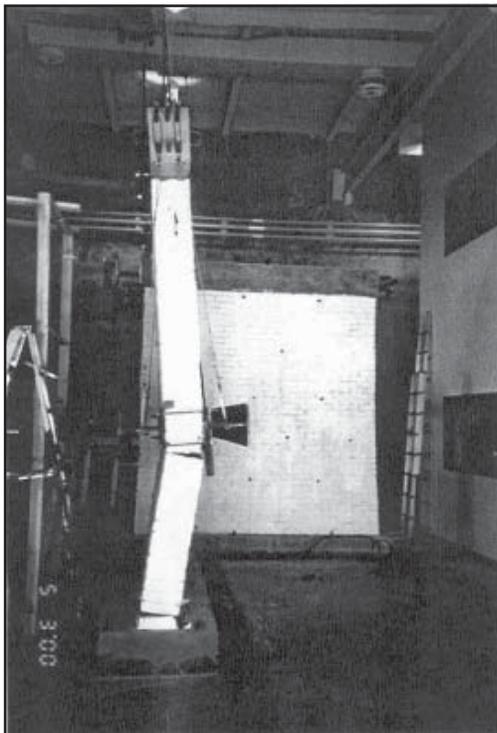
Figure 9—Failure of the Out-of-Plane Retrofitted Wall

close as shown in Figure 9. This rocking mechanism was similar to the mechanism developed in the repaired walls.

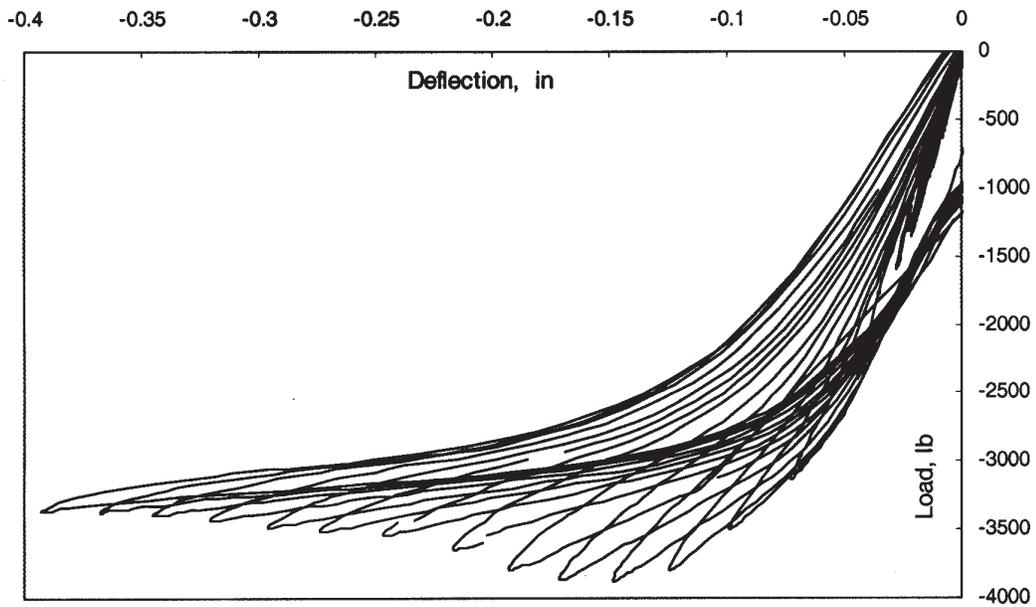
Figure 10—Load-Deflection Curve of the In-Plane Un-Injected Brick Wall (1 in. = 25.4 mm, 1 lb = 4.448 N)

first cycle was 0.005 inches (0.127 mm) and the increment was 0.005 inch (0.127 mm) per cycle. The vertical load applied on the top of the wall was not symmetric around the middle of the wall because of the weight of the actuator is applied on one side but not the other. Another reason is the uplift of the actuator when the wall is pushed versus no uplift when the wall is pulled. The resistance of the actuator to uplifting is high when the wall is pushed because the actuator did not have a hinge to allow for free rotations. This mechanism yielded a non-symmetrical hysteresis loops. It was decided to consider only the pulling side of the hysteresis loops because the actuator does not uplift in this case. Figure 10 shows only the pulling side of the hysteresis loops. The pushing side is omitted because it does not represent the pure strength of the wall. The wall failed in tension at the horizontal mortar joints

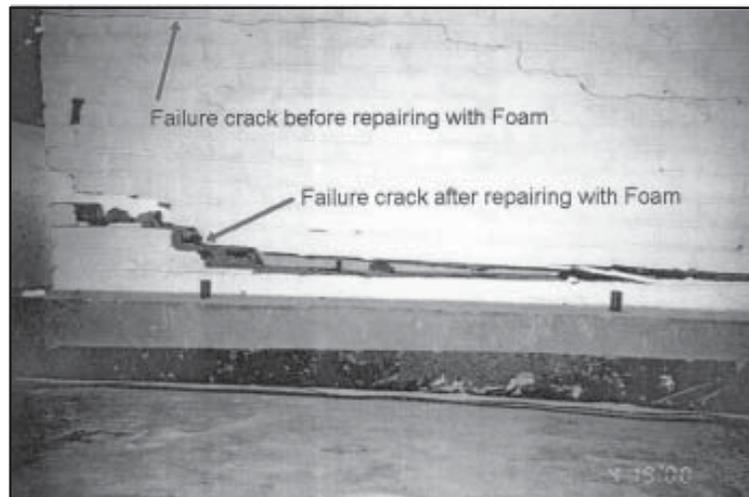
Figure 11—Failure Cracks of the In-Plane Wall Before and After Repairing with Expansive Epoxy

near the bottom of the wall as shown in Figure 11. Horizontal mortar joints near the bottom of the wall cracked and the portion of the wall above these joints started to uplift and rock in a rigid body motion. The ultimate capacity of the wall was 3,860 lb (17.2 kN). There were no signs of diagonal shear failure.

that, the wall was tested in two phases. The first phase was a monotonic test where the wall was pulled to a deflection of 0.25 inch (6.4 mm). As shown in Figure 12, the capacity of the wall has increased from 3,860 (17.2 kN) (plain) to 5,750 lb (25.6 kN), i.e. 49%, as a result of the expansive epoxy. This relatively large increase in capacity is attributed to the fact that the failure section after injecting the expansive epoxy shifted 22 inches (558.8 mm) towards the bottom of the wall as shown in Figure 11.

Figure 11 shows the wall at failure. It was observed that the cracks that opened during the testing of the un-injected wall remained closed in this test as a result of the expansive epoxy injection. In addition, the expansive epoxy helped in preserving the integrity of the wall by helping the mortar joints in transferring the loads between bricks. Due to the brittle nature of the mortar material, mortar fails first. The expansive epoxy material is more flexible than mortar and allows much more deformation before it fails. After the wall failed in tension by cracking at the horizontal mortar joints near the bottom, the part of the wall above cracked mortar joint started to rock in a rigid body motion. There were no signs of diagonal shear failure.

Figure 11 show the failure cracks before and after repair. The expansive epoxy sealed the original failure cracks and new cracks developed at a section near the foundation where there is little amount of or no expansive epoxy. As a result, it was decided to repair the wall again for the second time using fiberglass and epoxy. The fiberglass was glued to both wall and foundation to provide anchorage between the wall and its foundation, and to cover the area at the bottom of the wall where there is little amount or no expansive epoxy. As shown in Figure 15, the fiberglass anchorage was installed on one side of the wall only to simulate the real life conditions where only one side of the wall is accessible. The fiberglass also covered the second failure crack produced due to the previous testing of the repaired wall.

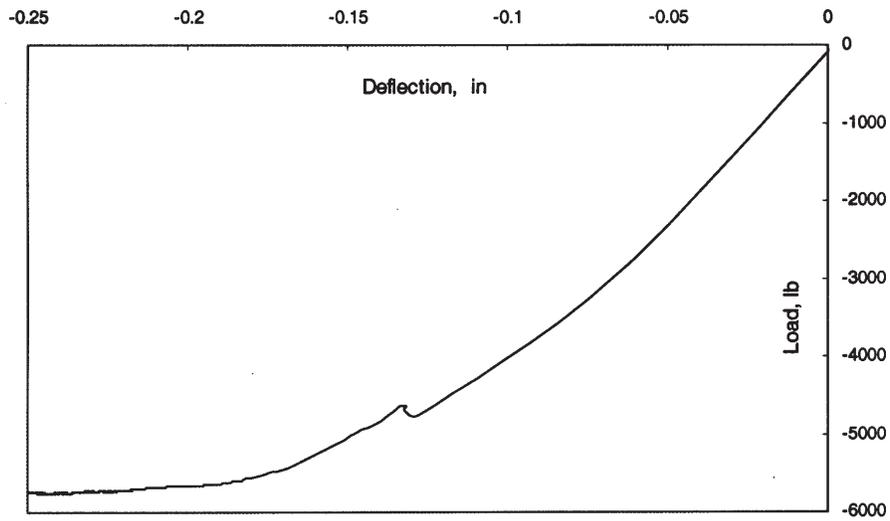
Figure 12—Load-Deflection Curve of the In-Plane Repaired Wall – Phase I: Monotonic (1 in. = 25.4 mm, 1 lb = 4.448 N)

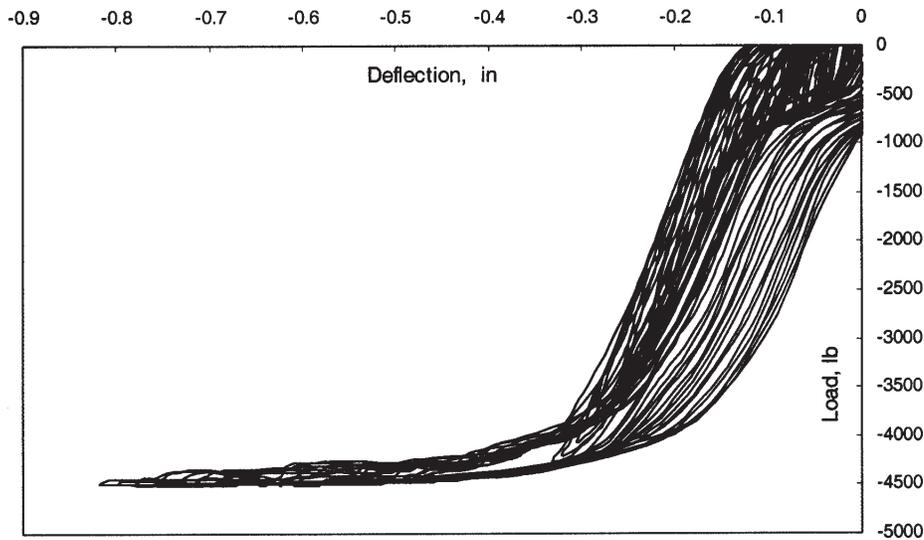
Figure 13—Load-Deflection Curve of the In-Plane Repaired Wall – Phase II: Cyclic (1 in. = 25.4 mm, 1 lb = 4.448 N)

The second phase was a cyclic displacement control test. The period was 10 seconds with initial amplitude of 0.02 inches (0.508 mm) and increments of 0.02 inch (0.508 mm) per cycle. This test was done after the wall has already developed a failure crack because of the monotonic test. Due to non-symmetrical loading conditions, only the pulling side of the hysteresis loops is shown in Figure 13.

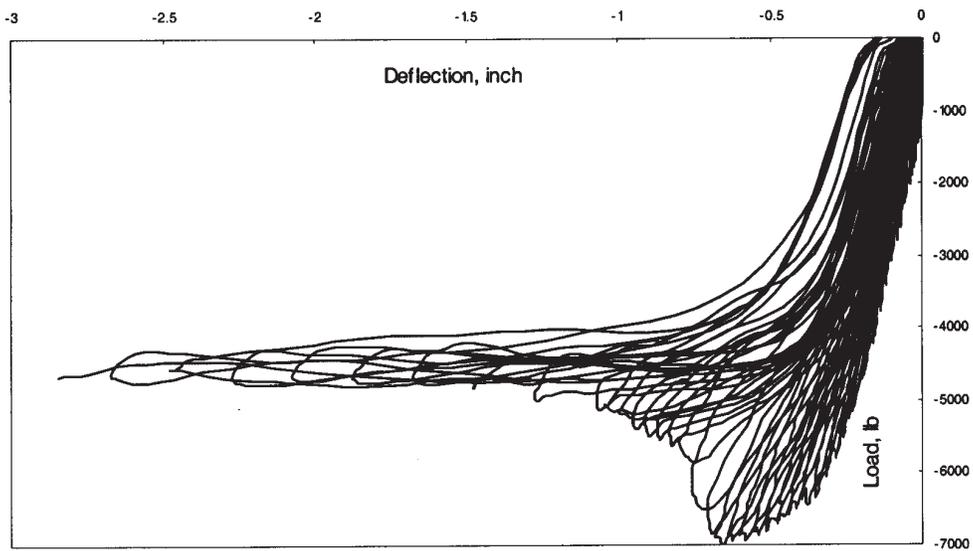
Figure 14—Load-Deflection Curve of the In-Plane Repaired Wall and Anchored to Foundation with Fiberglass(1 in. = 25.4 mm, 1 lb = 4.448 N)

0.1 inch per cycle. Figure 14 shows the hysteresis loops of the wall when subjected to such cyclic excitations. It was observed that the wall was cracked at a horizontal mortar joint section right above the fiberglass as shown in Figure 15, and the resistance of the wall increased considerably from 5,800 lb to 7,000 lb (25.8 kN to 31.1 kN), i.e. 21%. This increase is attributed to the fact that the fiberglass prevented failure at the bottom of the wall where is little or no expansive epoxy and forced the failure to take place in an area of the wall rich with expansive epoxy material.

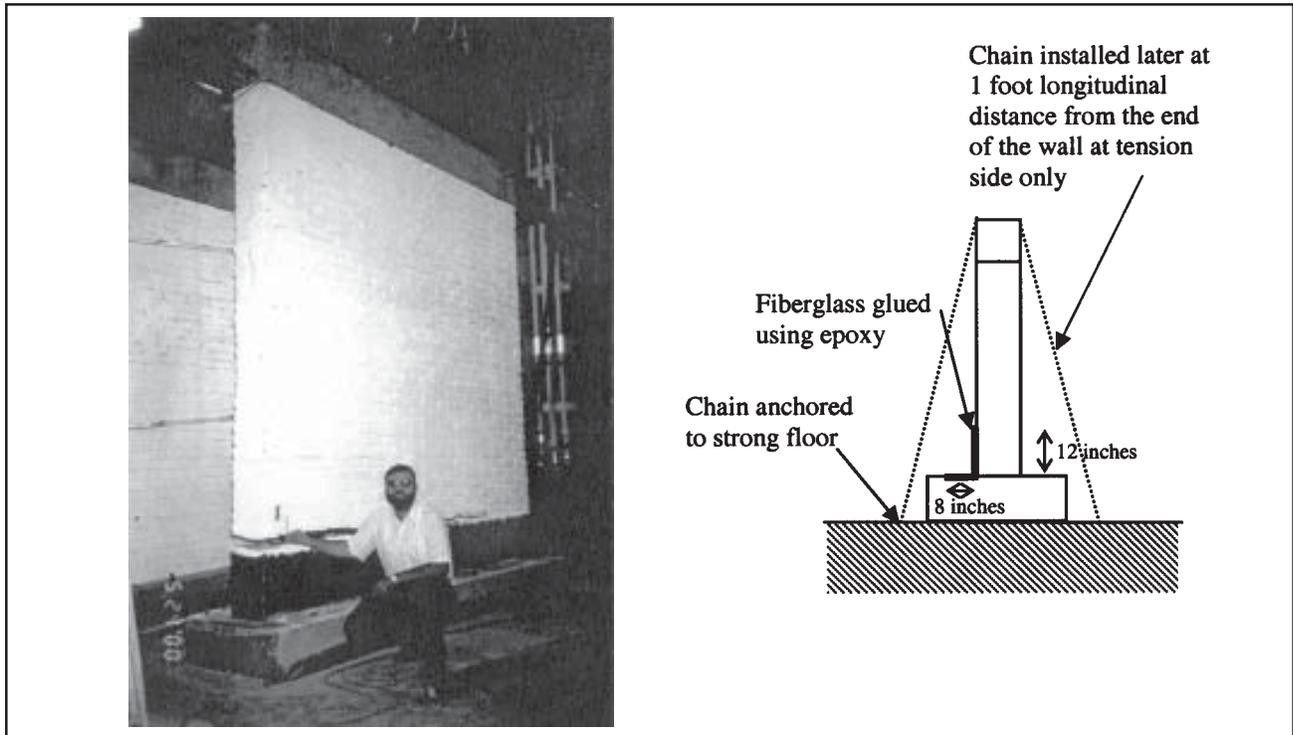
Figure 15—Failure of In-Plane Repaired Wall Anchored to Foundation with Fiberglass

The test was a cyclic displacement control test with amplitude from zero to the maximum value allowed by the actuator. During one cycle, the wall is pulled from the neutral position to predetermined amplitude and then returned back to the neutral position. The period of one cycle was 20 seconds. The amplitude of the first cycle was 0.01 inches (0.254 mm) and was increased by 0.01 (0.254 mm) inch per cycle. The period was increased to 20 seconds instead of 10 seconds to prevent the oscillations of weights hanged from the top of the wall. The test stopped as soon as the tension crack shown in Figure 17 was observed. The load deflection curve shown in Figure 16 indicates that the test was stopped at a deflection of 0.31 inch (7.87 mm). It was possible to continue the test beyond this point; however, it was decided to stop the test to install a chain that anchors the wall to the foundation to prevent the tension crack shown in Figure 17 from further progressing. Figure 16 shows that the wall is resisting a lateral load of up to 9,900 lb (44.04 kN), and it could resist more if the test was continued. That shows that increasing the axial load will increase the capacity of the wall from 7,000 lb (31.1 kN) to at least 9,900 lb (44.04 kN), if not more if the test is continued and the horizontal crack near the bottom of the wall shown in Figure 17 continues to develop. However, the test was stopped because it was desired to further explore increasing the axial load by installing a chain to anchor the top of the wall to the strong floor as shown in Figure 15.

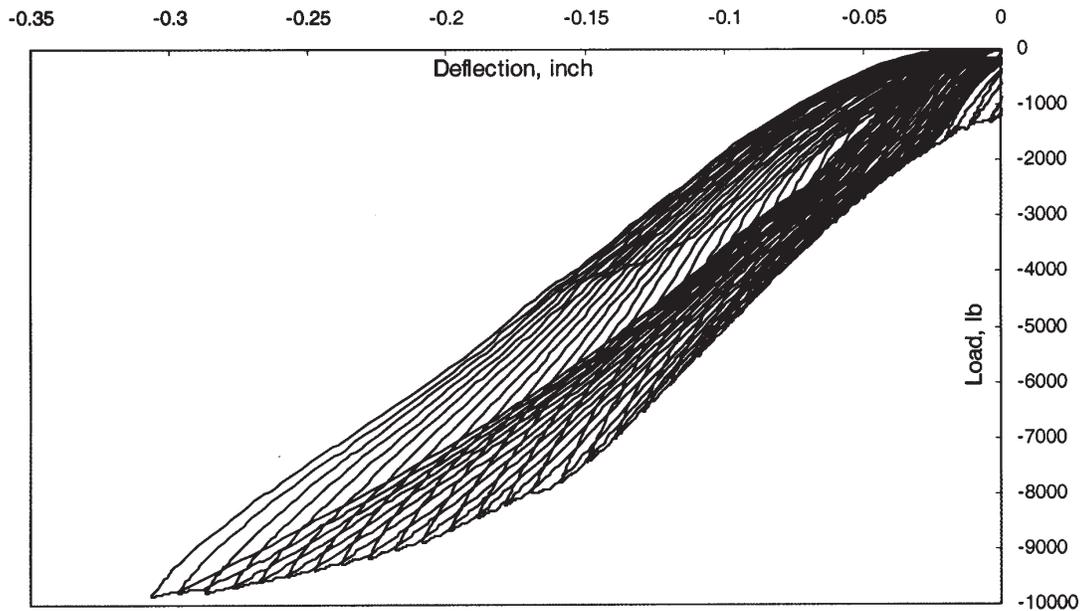
Figure 16—Load-Deflection Curve of the In-Plane Retrofitted Wall with Extra Axial Load and Anchored to Foundation with Fiberglass (1 in. = 25.4 mm, 1 lb = 4.448 N)

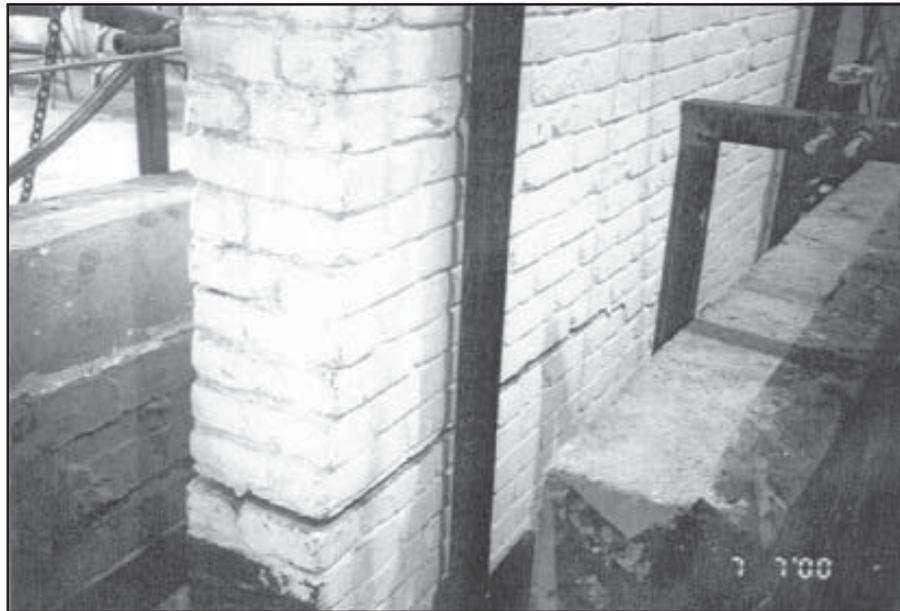
Figure 17—Initial Tension Crack of the In-Plane Retrofitted Wall with Extra Axial Load and Anchored to Foundation with Fiberglass

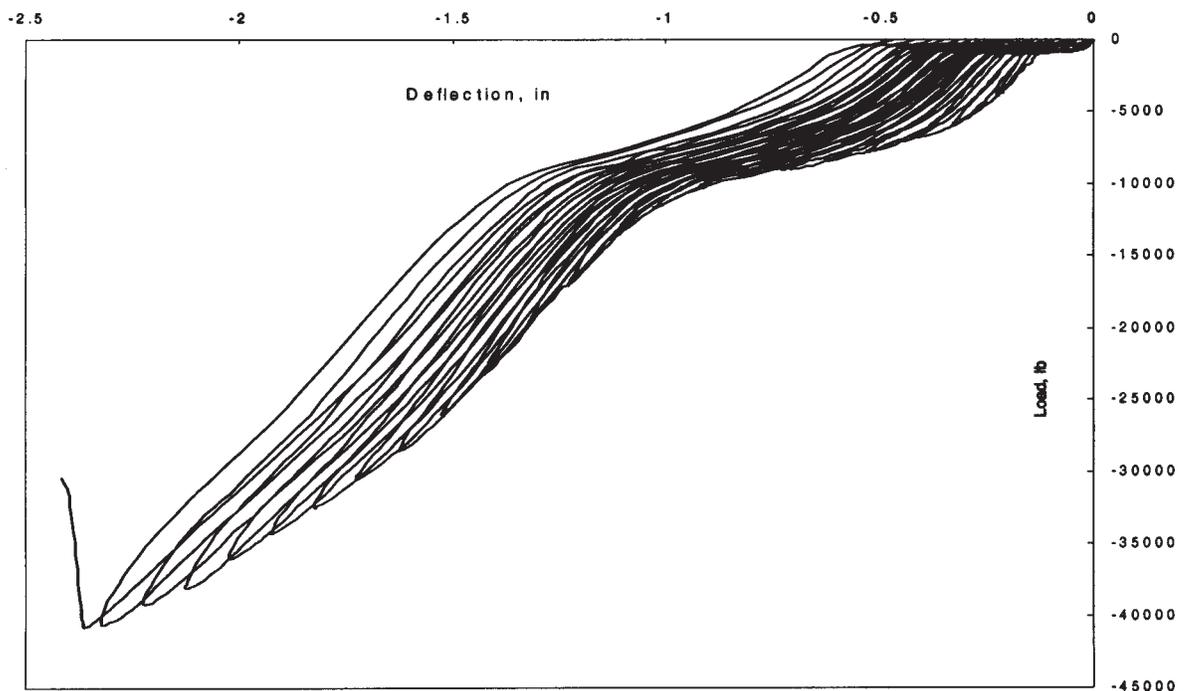
Figure 18—Load-Deflection Curve of the In-Plane Retrofitted Wall with Extra Axial Load and Anchored to Foundation with Fiberglass and Steel Chain

chain made the formation of horizontal tension cracks not possible due to the heavy axial compressive load. The chain did not totally prevent the wall from uplifting because the chain was not pre-stressed. The wall had to uplift some distance to stretch the chain and produce the desired axial load. Figure 18 shows the hysteresis loops until failure of the connection between the wall and foundation. The entire wall slid for a distance of 2 inches (50.8 mm) on its foundation and the foundation itself cracked as shown in Figure 19. The

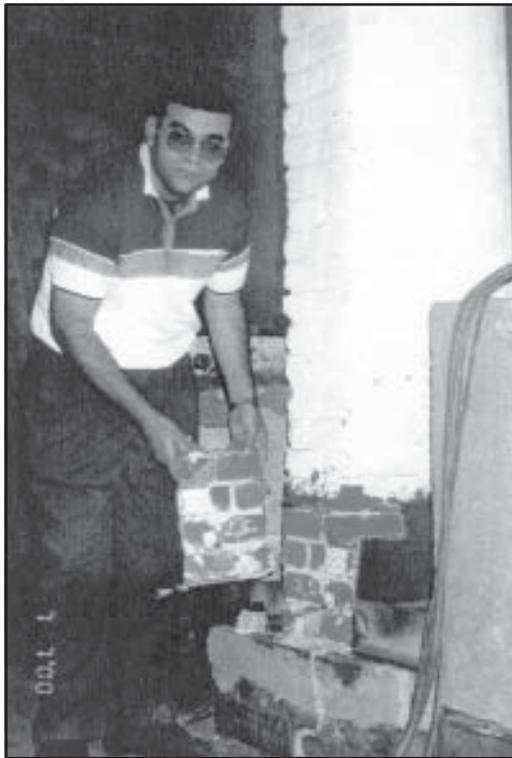
Figure 19—Sliding, Fiberglass and Foundation Failure of the In-Plane Retrofitted Wall with Extra Axial Load and Anchored to Foundation with Fiberglass and Steel Chain

wall itself showed no signs of any additional failure than the tension crack produced in the previous test. Before the wall slid, the fiberglass pulled out from the foundation due to the uplift of the wall. The wall was able to resist a load up to 41,000 lb (182.4 kN) before the sliding failure. Sliding failure took place in the connection between the wall and foundation

Figure 19 also shows a piece of fiberglass pulled out of the wall. It is clear from the picture that the bonding strength between the fiberglass and brick wall due to gluing epoxy exceeded the strength of the brick itself. This resulted in a thin layer of brick pulling out of the wall and remaining with the fiberglass. This leads to the conclusion that using such an epoxy, not exposed to moisture or weathering, in adhering the fiberglass to the brick wall is adequate because it provides bonding resistance, which is more than the shear resistance of the brick itself.

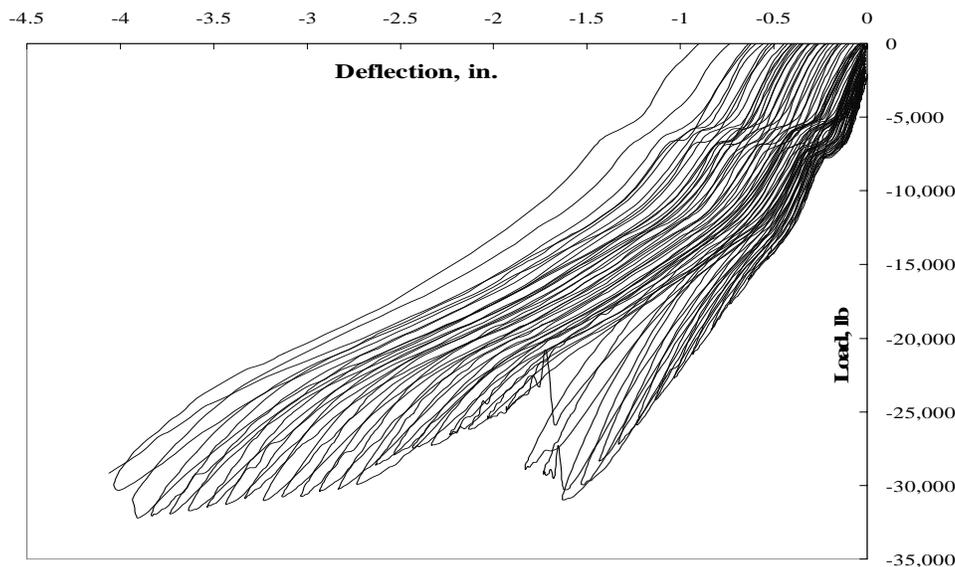
Figure 20—Load-Deflection Curve of the In-Plane Laterally Supported Wall with Extra Axial Load and Anchored to Foundation with Fiberglass

failure mechanism is expected in case of brick load-bearing wall supporting heavy axial loads. Figure 20 shows the hysteresis loops until the formation of the stair-steps diagonal crack. It shows that the strength of the wall against a stair-step diagonal tension failure is 32,000 lb (142.3 kN) and the deformation at failure is 4.1 inches (104.1 mm).

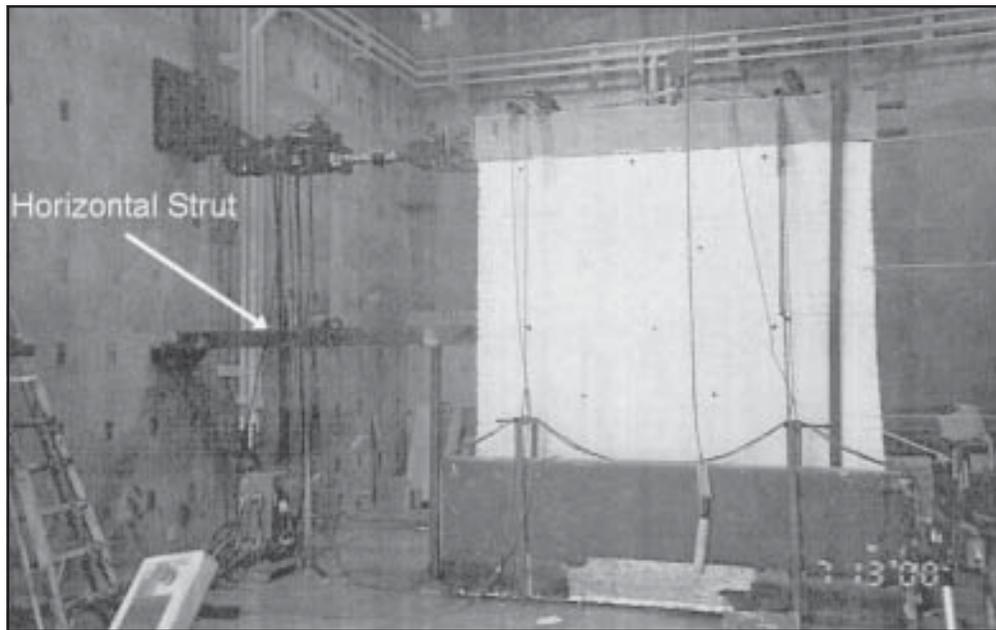
Figure 21—Test Setup of the In-Plane Laterally Supported Wall with Horizontal Strut Along with Extra Suspended Axial Load and Anchored to Foundation with Fiberglass and Steel Chain

The same wall was repaired again and tested for the third time as shown in Figure 21. This time, a lateral horizontal steel strut was installed at mid height of the wall to provide lateral support and to prevent the wall from going into further sliding when pulled. The objective was to force the wall to develop the expected diagonal tension failure, since sliding failure is not expected for such walls under heavy axial loadings, and to measure the corresponding strength of the wall. The effective loaded portion of the wall is the top half of the wall, which simulates a wall of aspect ratio of 2:1. That portion of the

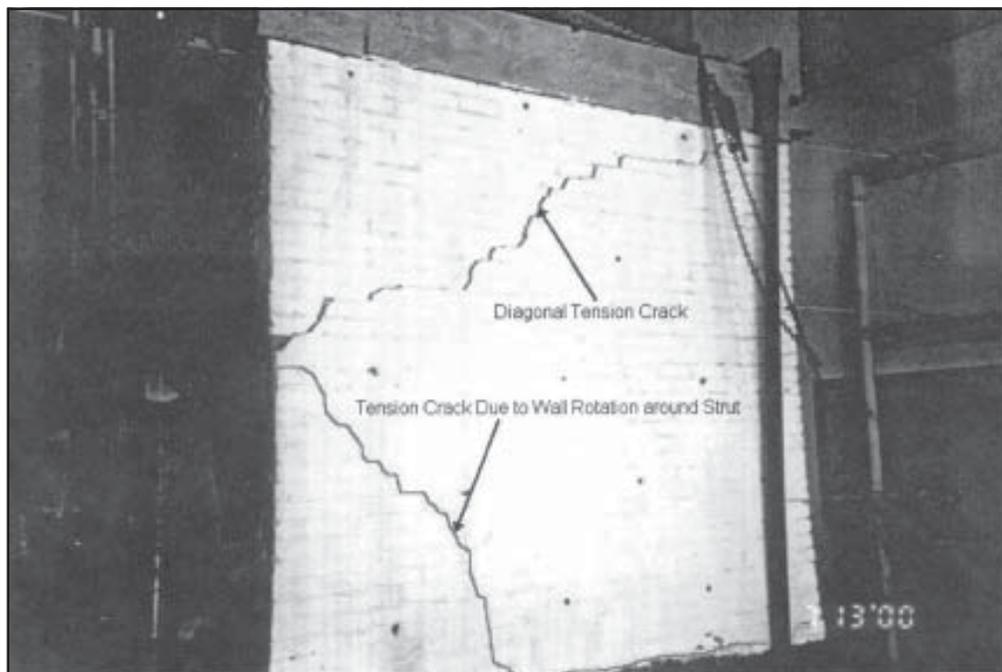
Figure 22—Failure of the In-Plane Laterally Supported Retrofitted Wall with Extra Axial Load and Anchored to Foundation with Fiberglass and Steel Chain

was 0.05 inch (1.27 mm) per cycle. The chain was kept in place to prevent the wall from uplifting and to provide extra axial loading when stretched. First, a curved tension crack was formed as shown in Figure 22 to allow the wall to uplift a little bit to stretch the chain. Such uplifting was necessary for the chain to develop enough axial loading to produce the desired failure mechanism. Then the stair-steps diagonal-tension crack was developed as expected. This
